ALERT

3 March 2010

CABLE PULL FAILURE

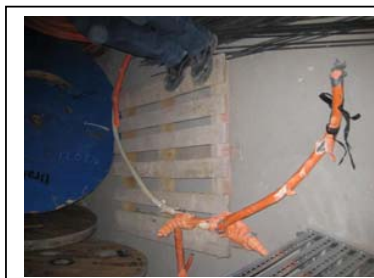
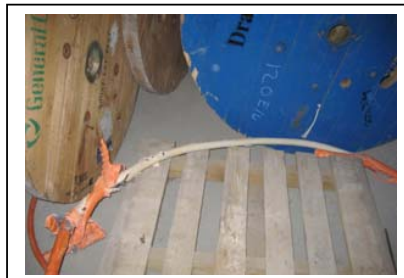
The cable's orange shield had stripped away from where the sock had been placed on the end of the cable. Refer to photos.

View of orange shield stripped away from 50mm fire rated cable.
