18th December 2009

Report

CFMEU WA

Principal contractor: H. R. Troons Pty Ltd

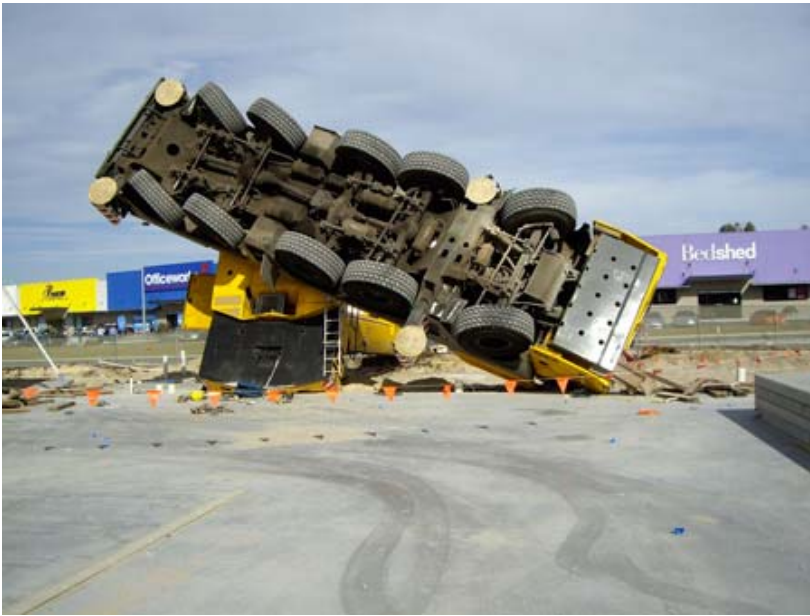
- It seems that the locking pin for the slew ring failed to engage properly, allowing the turntable to rotate, shifting the load of counterweights over the left side of the crane carrier. With outriggers in, this resulted in the crane falling over.

Rear view of toppled 160 Demag.

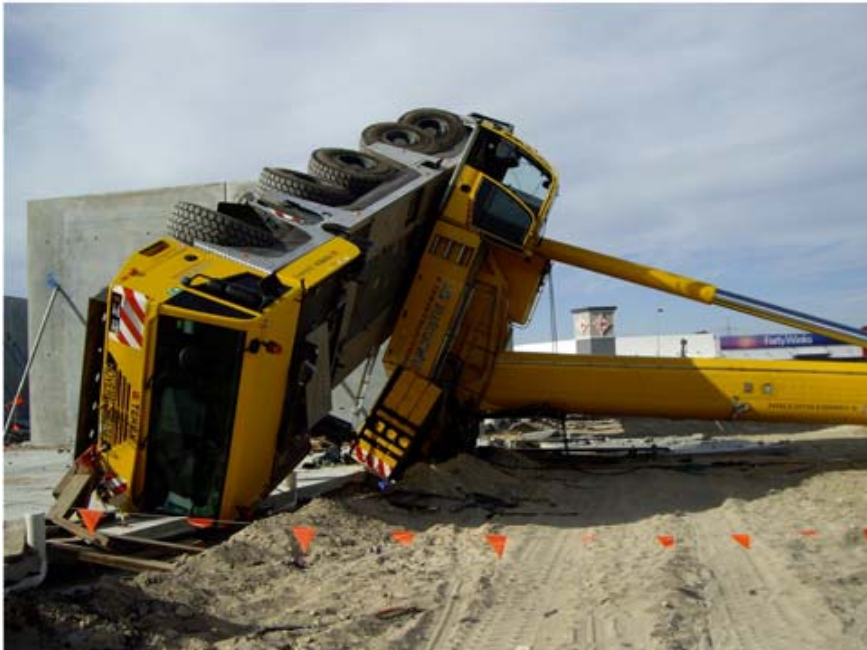
Front view of toppled 160 Demag.

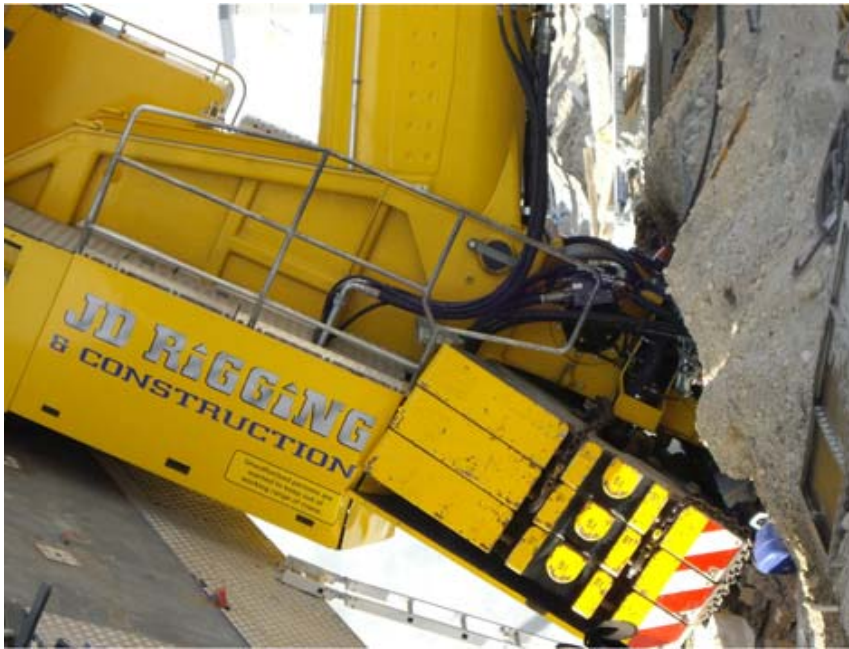
- The rear of the crane carrier also took out a tilt-up panel that was propped in final position.
- There were 28 tonnes of detachable counterweight mounted on the crane at the time.

28 tonne detachable counterweights.

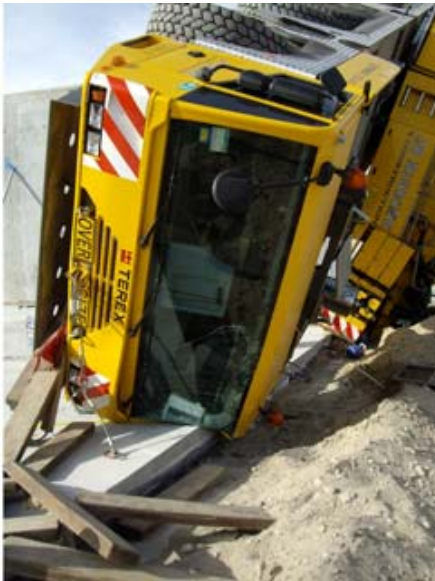
Crane carrier driver cabin.

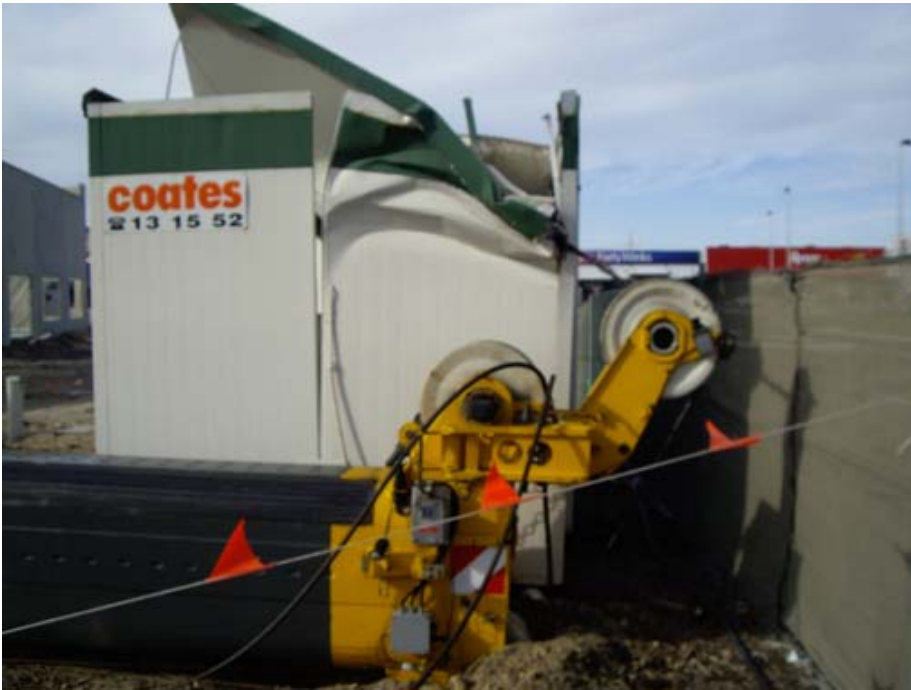
Crane boom alongside toilet block.

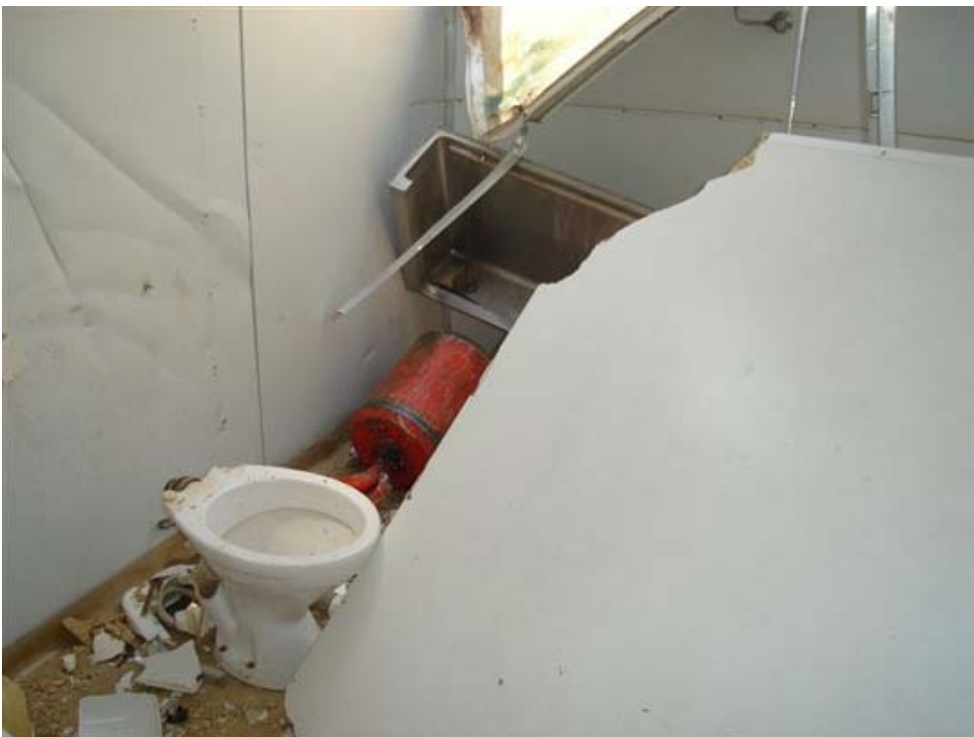
- Many personnel on site were in shock but no-one had any physical injuries.
- The single hook and headache ball had catapulted through the left side of the toilet block destroying urinal and pan – 'just luck no-one was using them at the time'.

Hook and wire rope that sliced through toilet block.

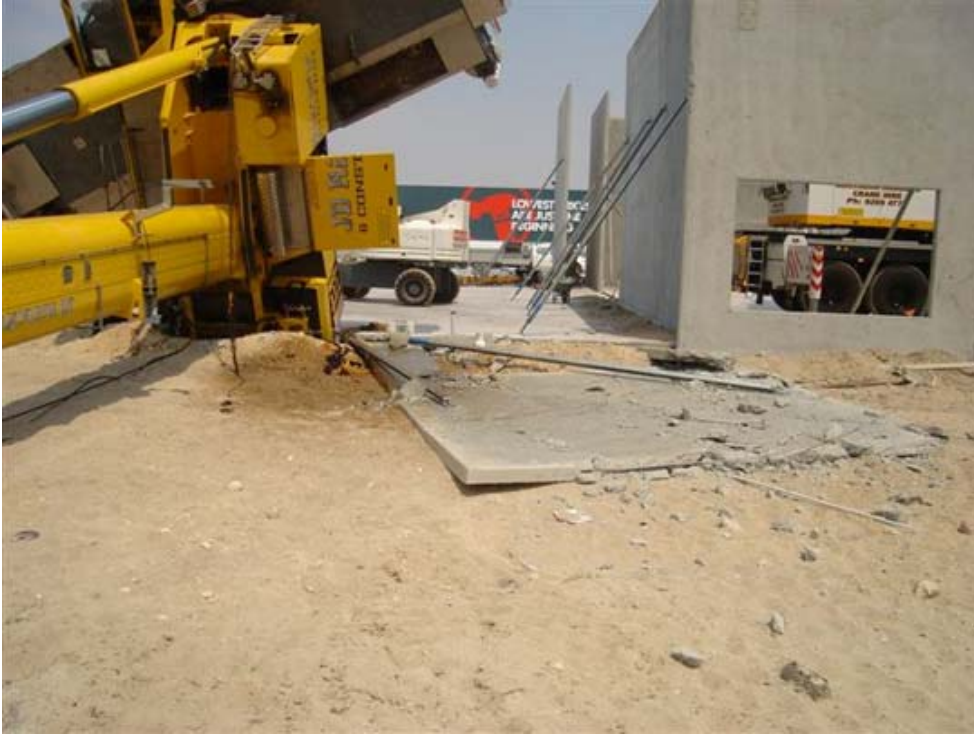
Tilt-up panel that fell when struck by crane carrier.

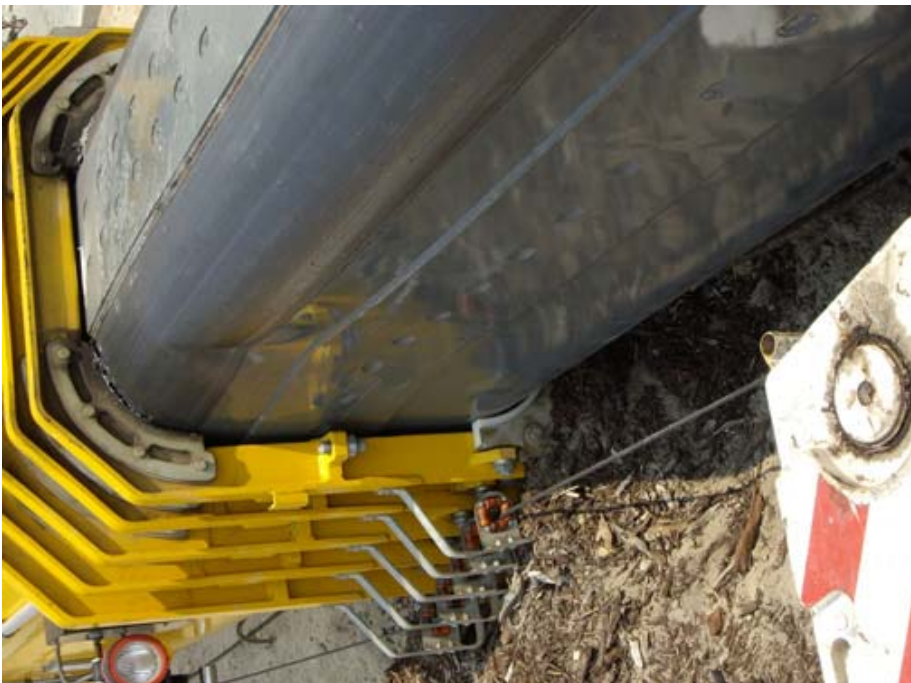
View showing damage to boom section.

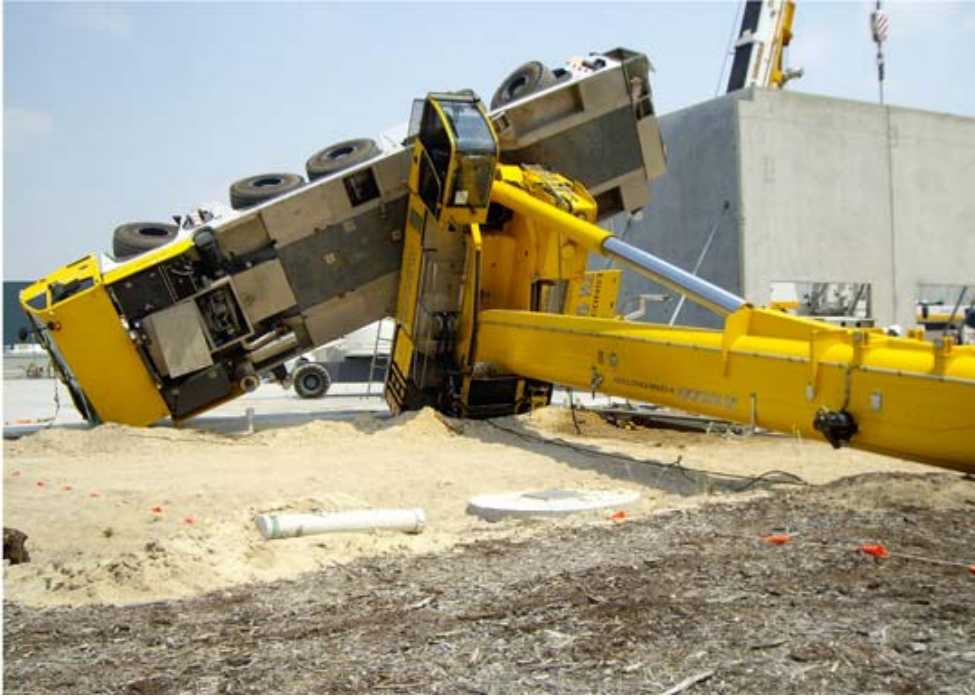
View of Demag crane prior to recovery.

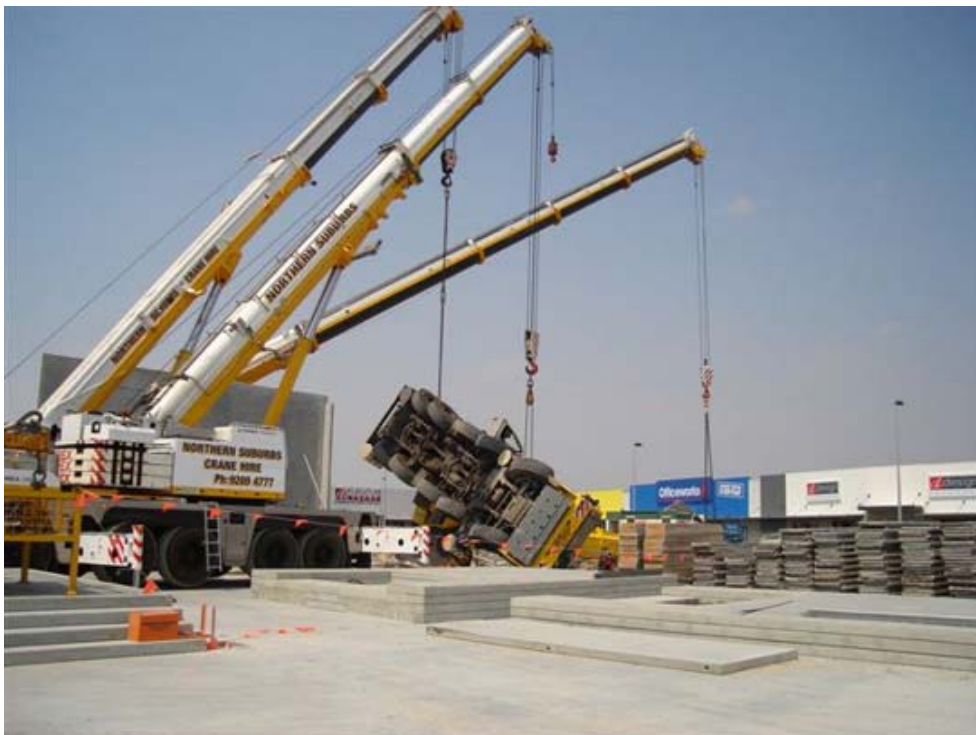
Damaged crane is rigged up for recovery lift.

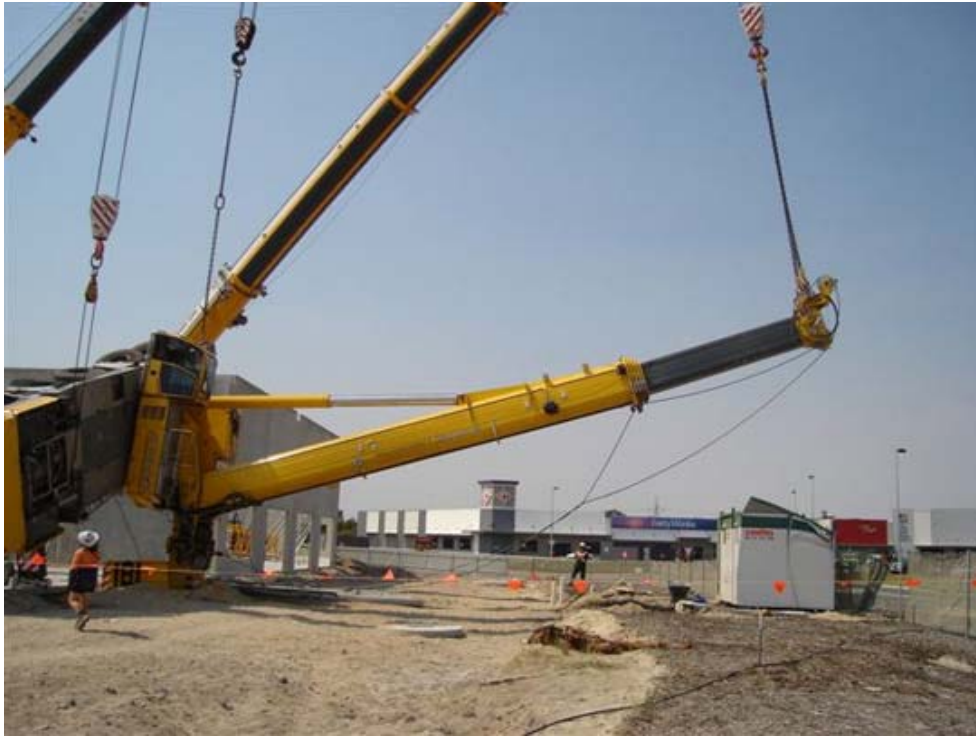
Crane 1 takes weight of boom section.

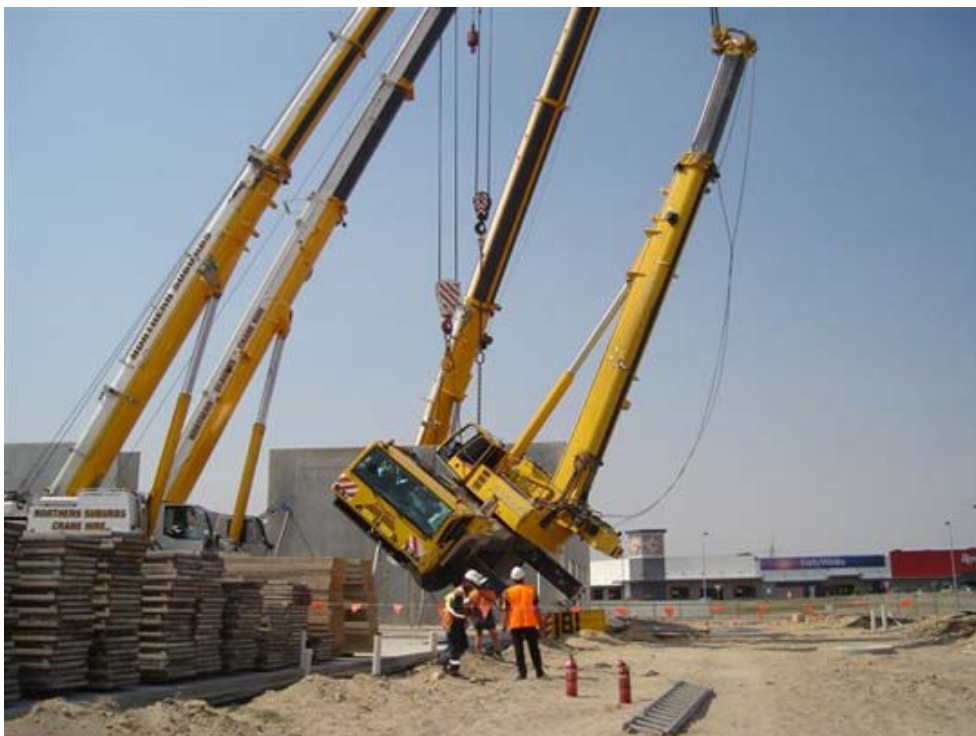
Cranes 2 & 3 take weight and lift carrier.

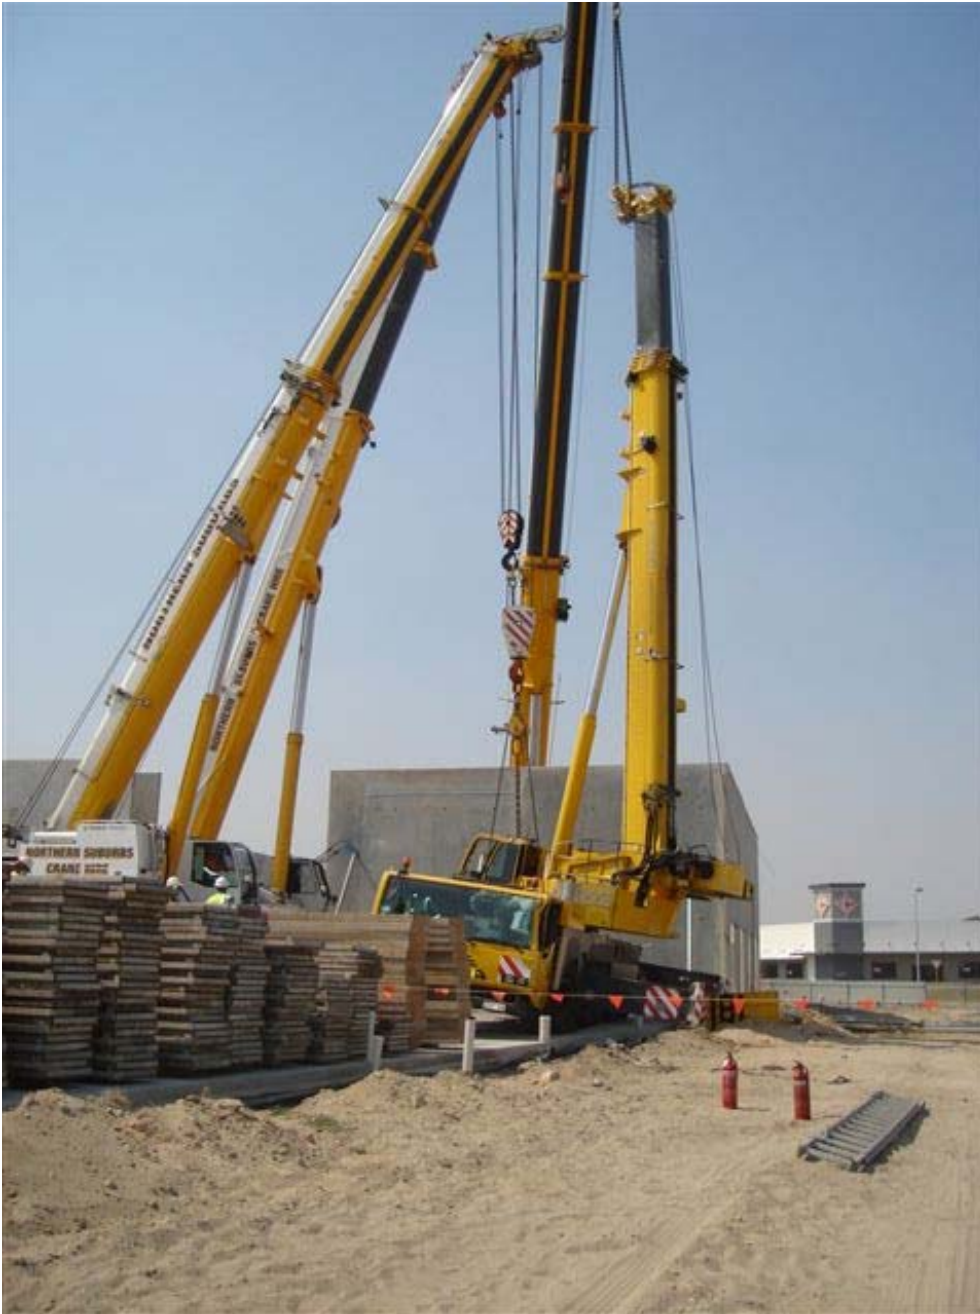
Crane is rotated back on to wheels.
