Report

**CFMEU Construction & General Division
NSW Branch**

Principal Contractor – Rock and Earth Exchange

Address – Menangle Park Paceway Menangle Park NSW

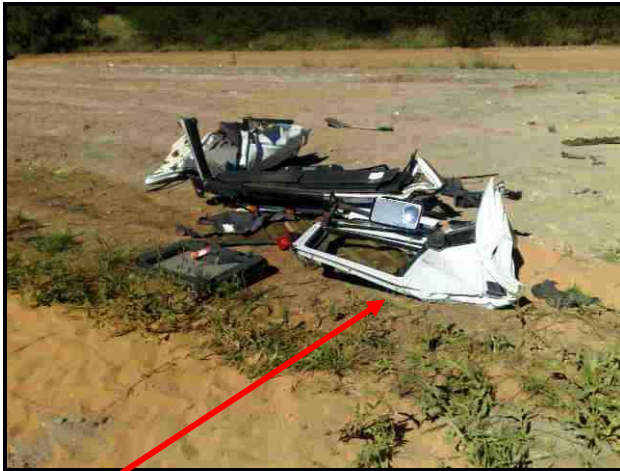
It would appear from the available evidence that the major contributing factor in this fatality was the placement of the prime mover in relation to the trailer i.e. being placed in the "V" (acute angle) in relation to the trailer. This had the effect of following actions:-

3. Articulating the prime in relation to the trailer (acute angle) in the event of a roll over, there can only be one result, a crushed prime mover cabin. The driver must ensure that the prime mover and trailer are in a straight line.

View Showing remains of truck cabin

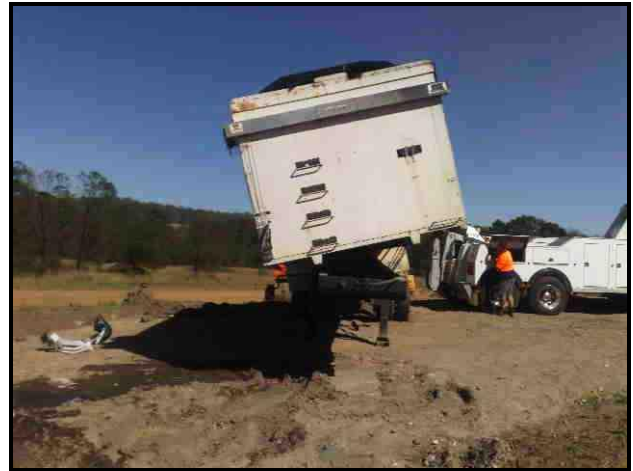
1. Preventing the soil/load from being tipped as it would have a backup effect on the trailer.
2. Because of the backup effect on the load e.g. the soil/load would still be at the apex of the trailer as it was raised. This would contribute to the overturning moment if the trailer was not perpendicular.

4. By articulating the prime mover and trailer into a "V" formation the deceased was not able to drive forward to release/shake the load and prevent the material from backing up. This type of truck trailer configuration because of the volume of material in the trailer have propensity to choke up. Because of the uneven spoil load (rocks one side dirt the other) more weight can be on one side of the trailer than the other. At height this can have a devastating effect.

View Showing tipper trailer appears to have a twist

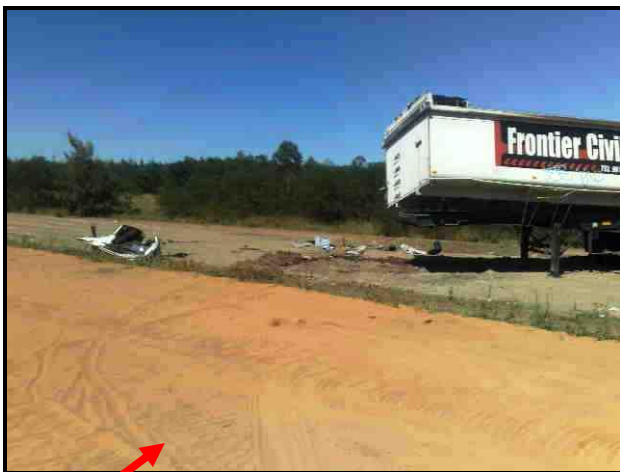
The tipping face was relatively flat with some camber evident. The area where the incident took place had been graded over by the bulldozer operator to remove any evidence of the incident. It presented as neat and tidy.

View showing area of incident yellow sand forms part of horse training track.

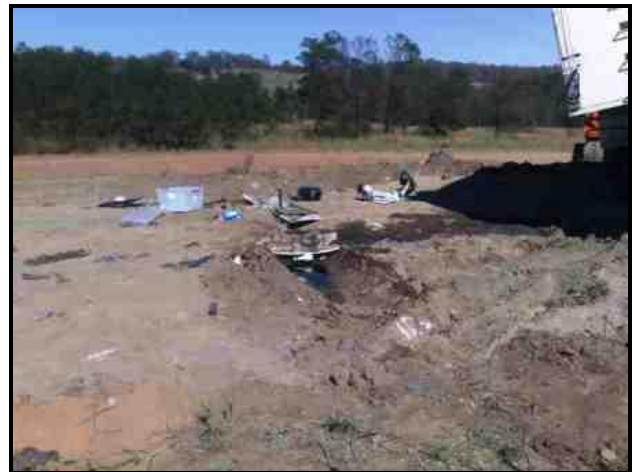
View showing area of incident. Area appears level.
