BACKGROUND:

The make and model of the crane is a Zoomlion PUYUAN QY 40V (40 Tonne) Chinese manufacturer.

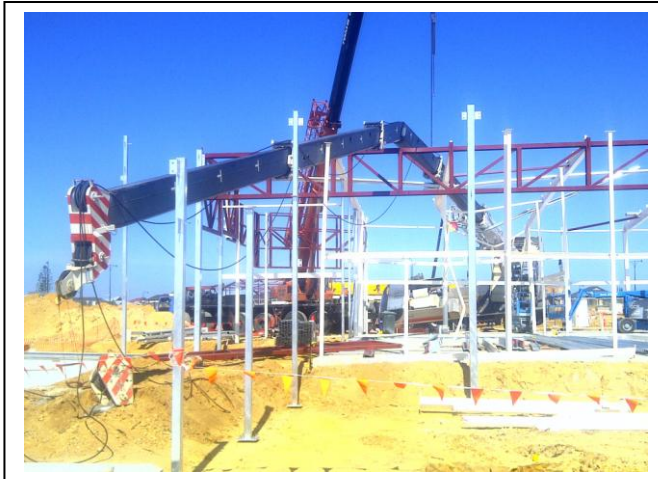
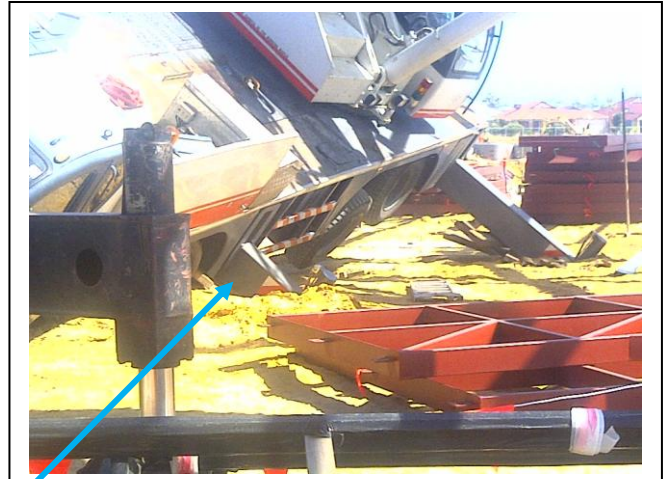
During the steel erection process on a northern suburbs construction site, a crane has suffered a major mechanical failure. The crane was attempting to position a 850kg roof truss when the connection between the hydraulic ram and the outrigger has failed, causing the crane to fall across the partially erected steel structure narrowly missing the riggers onsite.

Failed outrigger

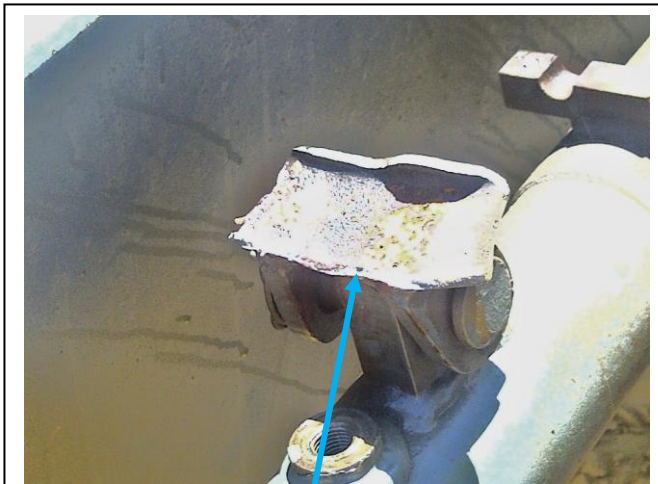
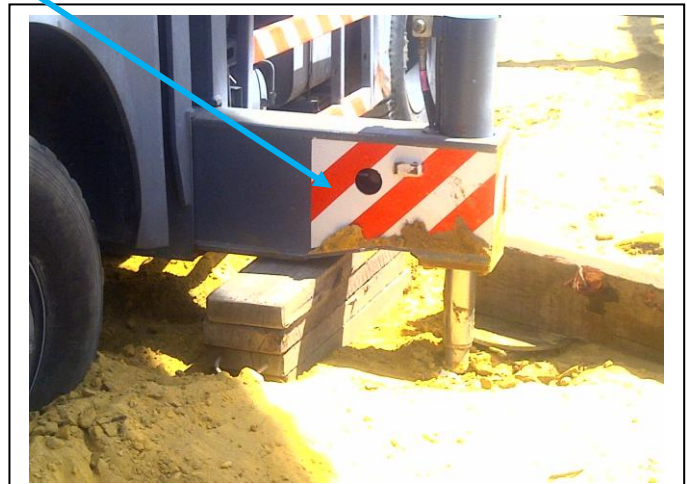
A closer inspection of the outrigger revealed that the connection was manufactured from poor cast iron material, with little or no structural integrity.

Poorly manufactured hydraulic ram connection

Further enquiries have revealed that the crane, a cheap Chinese import has had a string of failures relating to the outrigger assembly. It is recommended that these cranes be scrutinised upon arrival to any worksite.
