Report

**CFMEU Construction & General Division
NSW Branch**

Principal Contractor – Rock and Earth Exchange

Address – Menangle Park Paceway Menangle Park NSW

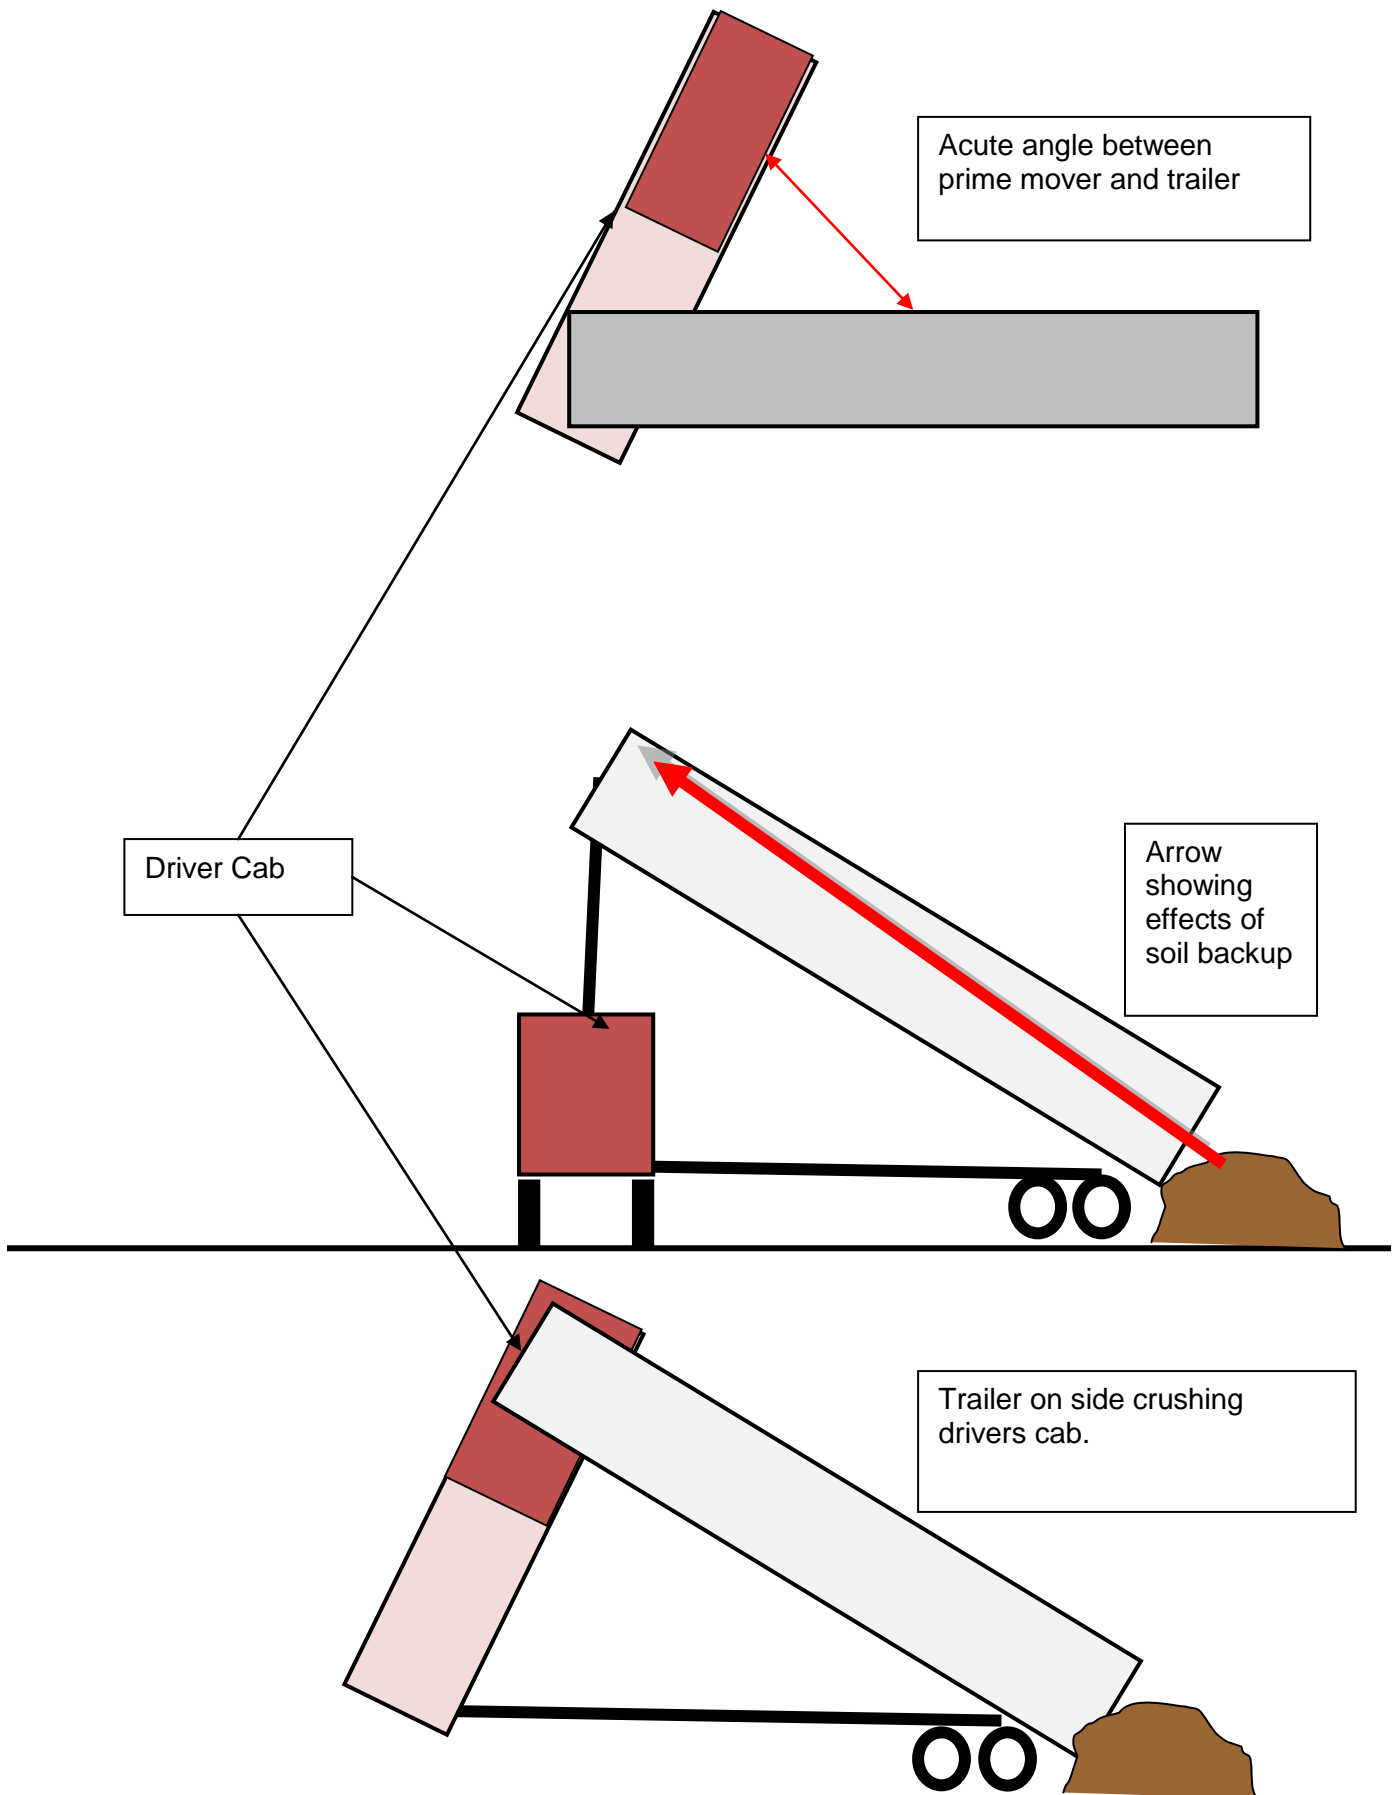
The tipping face was relatively flat with some camber evident. The area where the incident took place had been graded over by the bulldozer operator to remove any evidence of the incident. It presented as neat and tidy.

View showing area of incident. Area appears level.
