## Unmarked scaffold couplers

This Alert highlights the need for scaffold couplers to be marked in accordance with Australian Standards.

May 2010

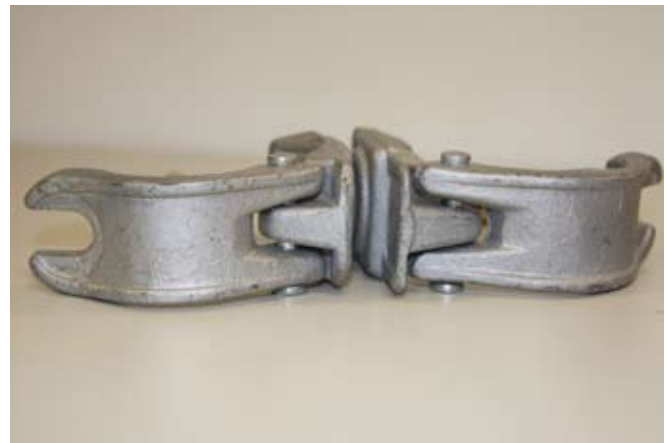
Unmarked scaffold couplers (swivel and right angle reduction couplers) that are commonly used to brace formwork frames and props were recently found on a construction site.

Example of unmarked scaffold coupler

- all scaffold couplers and accessories, except baseplates, are marked
- couplers and accessories manufactured after the publication of AS 1576.2 -2009 meet the marking requirements of that standard
- any scaffold coupler or accessory not marked is removed permanently from service and the supplier notified.
