## CFMEU ALERT

### FORMWORK SHUTTER & LIFTING POINTS

On Monday 31st Oct 2011, a 65 yr old Formwork Foreman was fatally injured on a project at the Queensland University Campus St Lucia, when a concrete formwork shutter being lifted by a crane suffered a catastrophic failure at the lifting points.

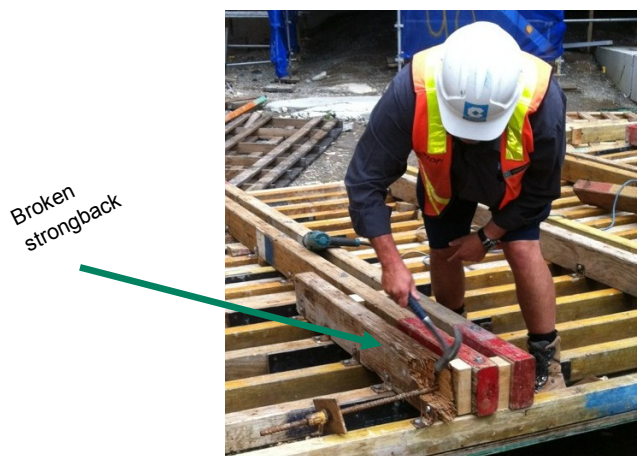
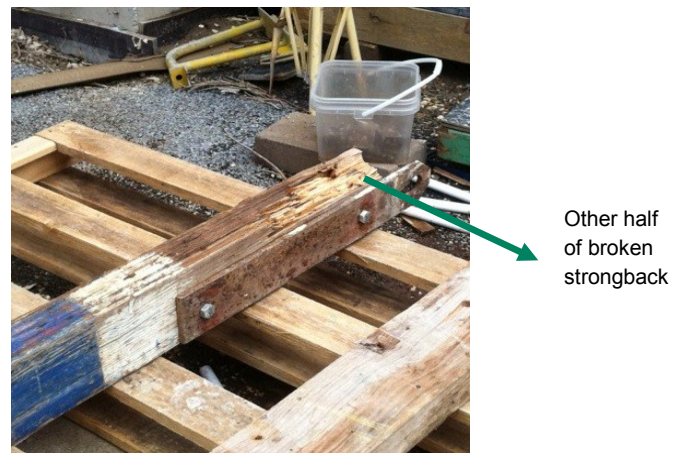
It would appear the shutter was being extended in height by at least the width of a sheet of form ply, and was going to be used to form a higher wall. Extra strongbacks that were not part of the original shutter design had been fitted and were some 1.2-1.5 metres higher. It is believed that the shutter was in the process of being lifted up by a crane to turn it over to fit the extra soldiers and form ply needed for the extended height, when the failure happened.

The extended strongbacks appear to have failed under the extra load exerted by the lateral force of the attached lifting chains causing the shutter to tragically fall on the worker.

Ensure that Engineers approval is received and verified on the design and construction of all Formwork shutters.

All lifting points are be part of that approval, and a record of maintenance and use must be available for inspection at any time.

Any modifications to the original engineer approved design of any Formwork shutter must be approved and verified again by an engineer before use.

All contractors and supervisors to be aware of their obligations when making , modifying or lifting Formwork shutters.
