ALERT

August 2005

Failure of Prefabricated stair unit

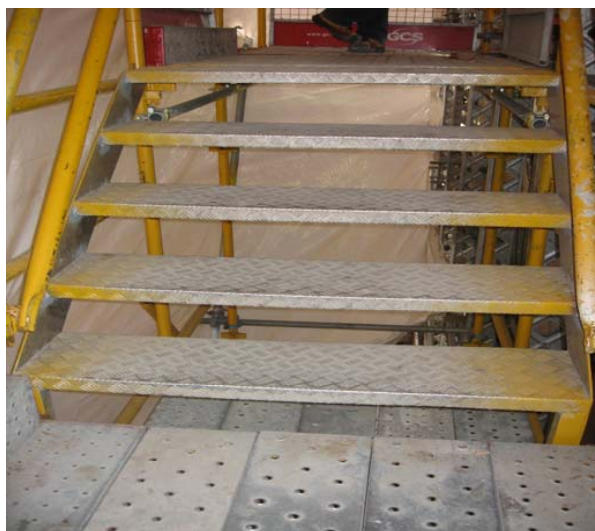
The failure has allowed enough movement in a prefabricated stair unit to become dislodged from the supporting transom resulting person falling approx 10 meters to the ground below. *Inspections on various other sites found prefabricated aluminium stair units with similar issues.*

Prefabricated aluminium stair unit

- Ensure that any prefabricated stair units in use are physically secured by use of a tool.
- Businesses that hire out aluminium stair units ensure that each unit is inspected for defects between each hiring to ensure no unsafe units are supplied for use.
- Check to ensure that there are no bent treads, bent stringers, broken or bent pins, broken welds and assembly is not twisted.
- Scaffolders have important responsibilities to visually inspect scaffolding equipment for faults prior to installation.
- Rejected scaffolding components should be recorded, isolated and clearly marked to prevent reuse.
